Monthly Oversight Report 42  
ACS NPL Site  
Griffith, Indiana  
May 29, 2004 - June 25, 2004

Subject: Monthly Oversight Summary Report  
No. 42 for June 2004

**Monthly Oversight Summary Report No. 42**  
**ACS Superfund Site WA57, 46526.238**

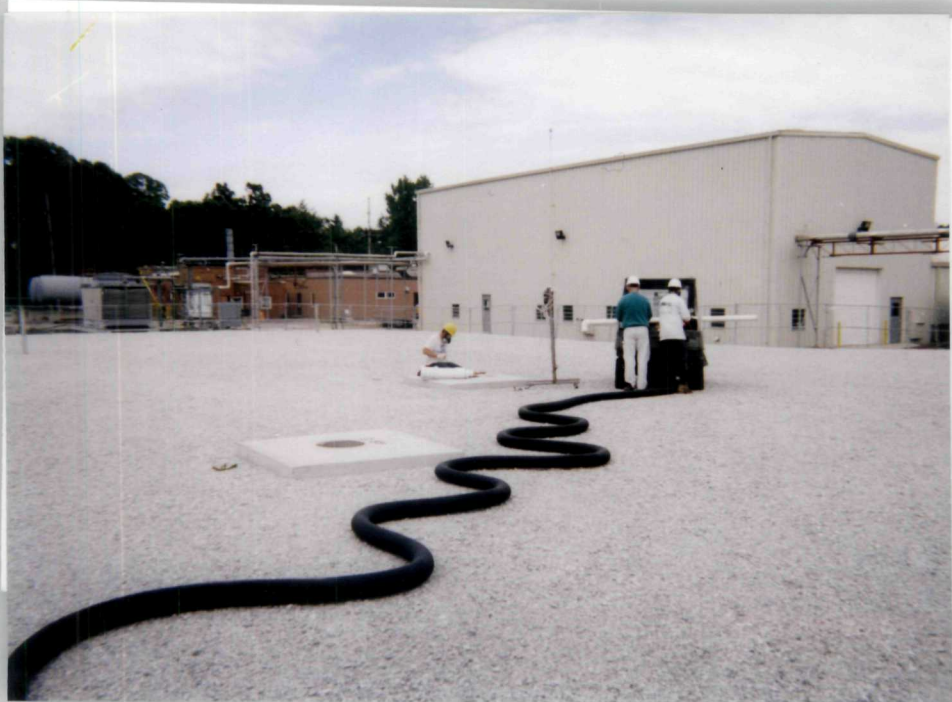
Description: Photo facing southeast showing MWH removing vacuum connection piping from ONCA SBPA ISVE system well SVE-65.

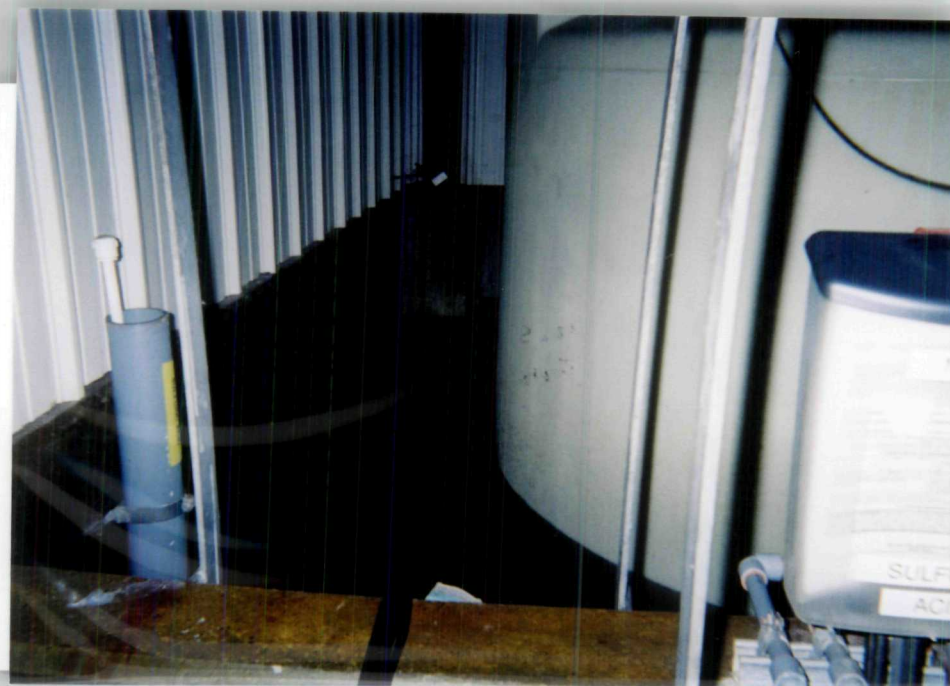
Description: Photo facing west on south side of tank T-9 showing the diluted sulfuric acid (black) in the secondary containment.

MWH reported that it observed a leak in the sulfuric acid tank in the GWTP on June 7, 2004. MWH initially transferred a small amount of the sulfuric acid into a 30 gallon tank for temporary storage. MWH

reported that by the end of the week of June 7, 2004, sulfuric acid was present in the secondary containment to a depth of 1 foot. MWH added sodium hydroxide to the sulfuric acid in the secondary containment in an attempt to neutralize the pH. The reaction released heat, and MWH then added water to the mixture to cool it. Black & Veatch Special Projects Corp. (BVSPC) asked MWH if the Operations and Maintenance (O&M) Manual for the GWTP addressed spill counter measures and response actions for cases such as the leak from the sulfuric acid tank. MWH reported that it did not review the O&M Manual prior to responding to the leaking tank. BVSPC suggested that MWH prepare a job hazard analysis to evaluate the health and safety issues associated with addressing the leaking sulfuric acid. MWH completed an incident form detailing the incident that occurred and the health and safety procedures that would be followed when mitigating the incident. MWH reported that its corporate health and safety officer suggested that it prepare a procedure for inclusion in the O&M Manual that specifies the actions that should be taken in the event of another acid leak.

An inspection of the sulfuric acid tank indicated that there were two leaks. One leak was at the inlet port and the other at the outlet port. MWH is reviewing the options of repairing the tank or replacing the tank.

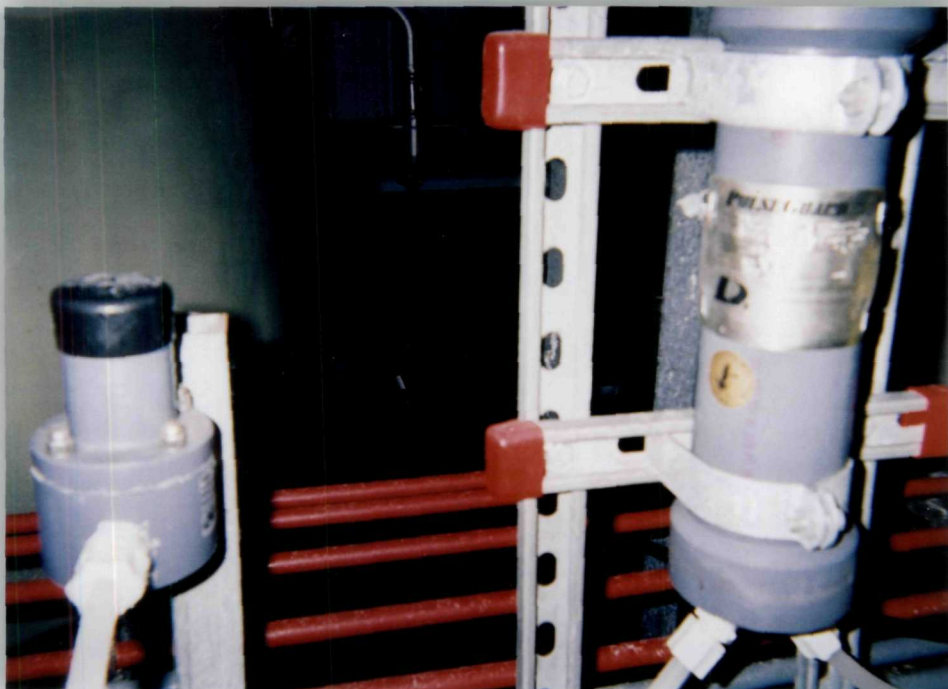
Description: Photo facing west on the north side of tank T-9 showing diluted sulfuric acid in the secondary containment.

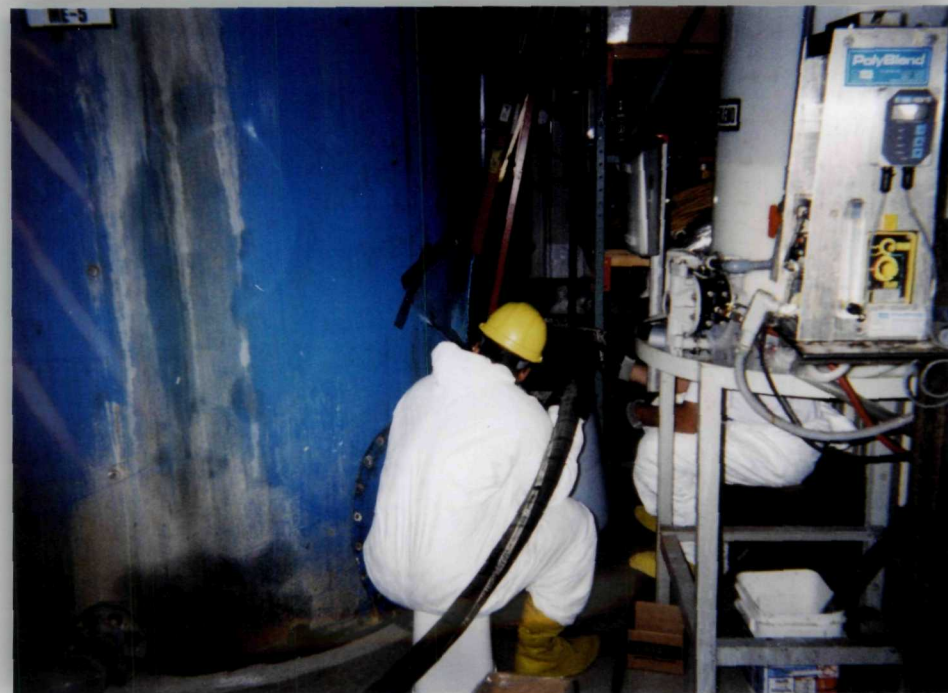
Description: Photo facing east showing IES cleaning sludge from the lamella clarifier.

Independent Environmental Services (IES) was onsite on June 16 and 17, 2004, to remove the sludge from and to replace the shear pin for the sludge rake in the lamella clarifier. IES donned level C PPE during the repair work. IES also replaced the filter fabric on the sludge press on June 17, 2004. Austgen also replaced the demister in tank T-102 on June 16, 2004. MWH operated the GWTP during the reporting period at 25 to 30 gpm except for the approximately 6 hours on June 16, 2004, when IES cleaned and repaired the lamella clarifier. MWH reported that a leak in one of the granular activated carbon (GAC) vessels was observed during the week of May 31, 2004. MWH took the leaking vessel offline and began operating one GAC vessel only. Simalabs collected samples from the GWTP on June 24, 2004, for routine process monitoring.

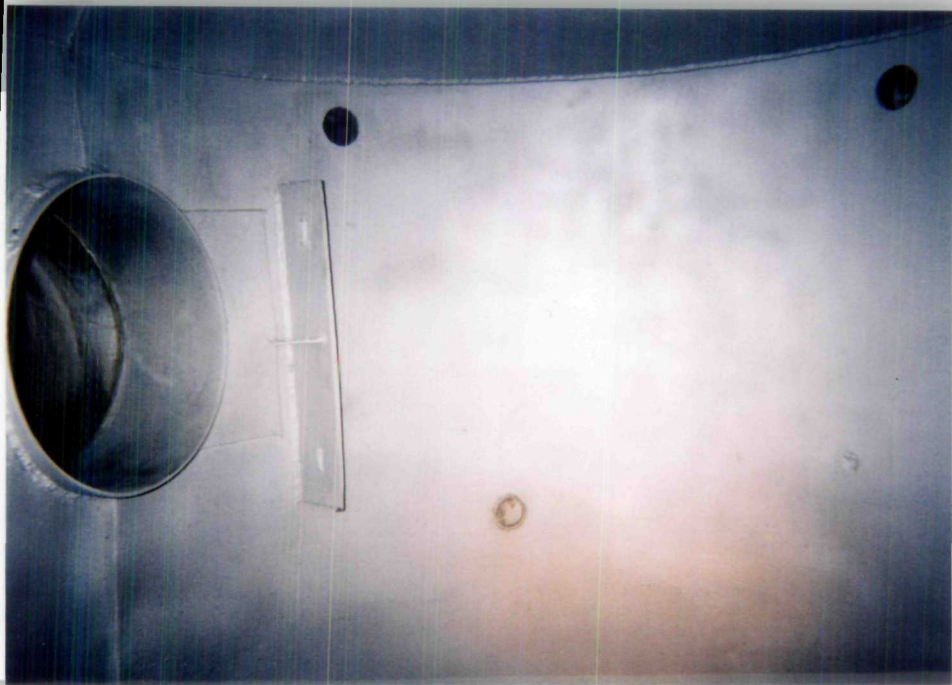
Description: Photo facing south showing the interior of the Durr thermal oxidizer unit 1 scrubber after being sand blasted by CTL.

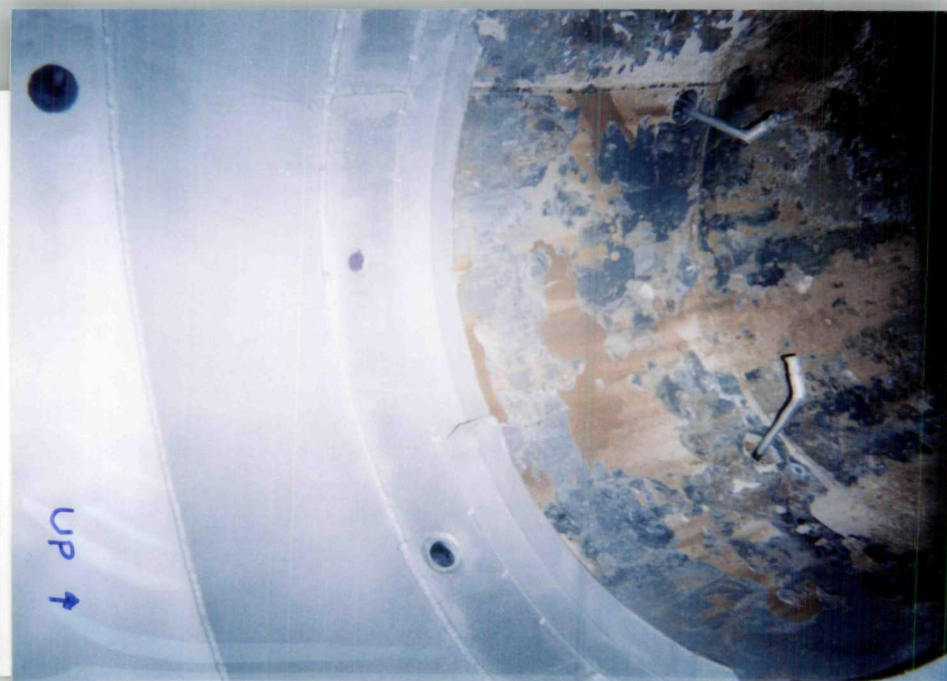
Description: Photo looking up into the interior of the Durr thermal oxidizer unit 1 scrubber. Material at top of photo illustrates interior of scrubber stack before sand blasting.

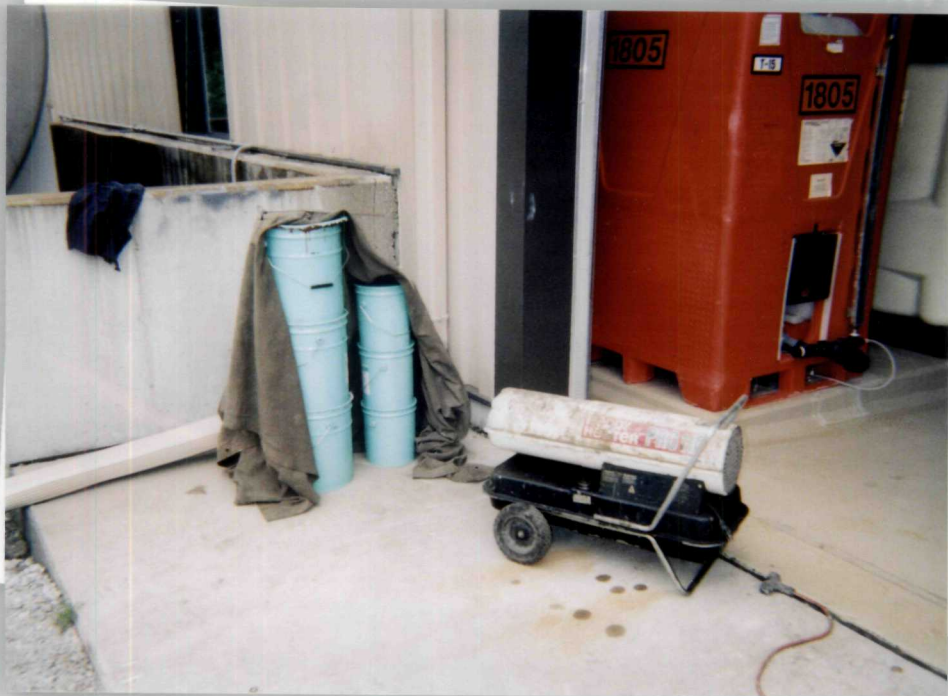
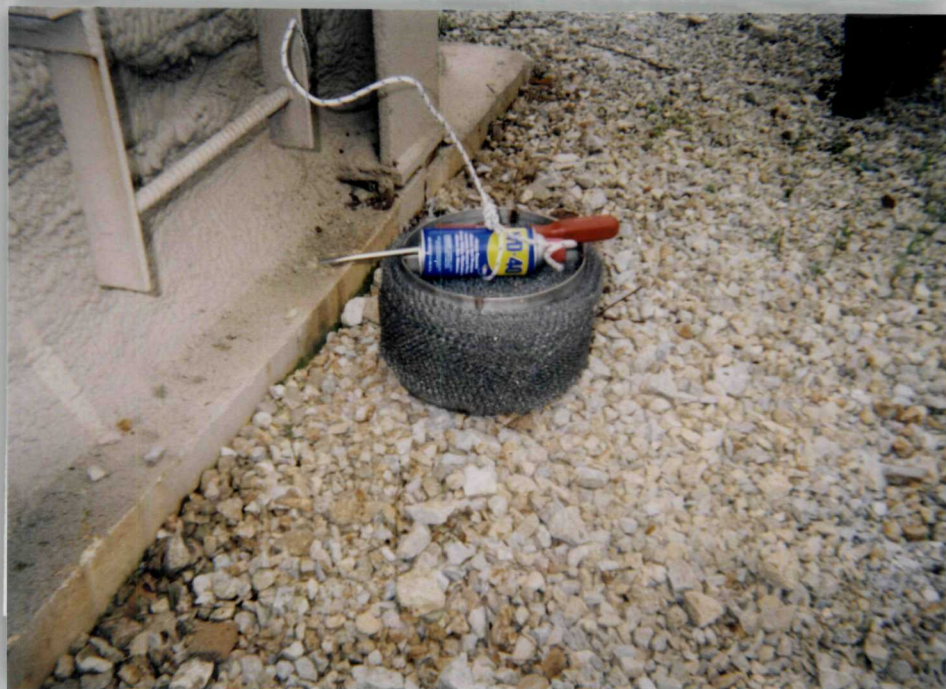
Description: Photo facing south showing the new demister that will be installed into tank T-102.

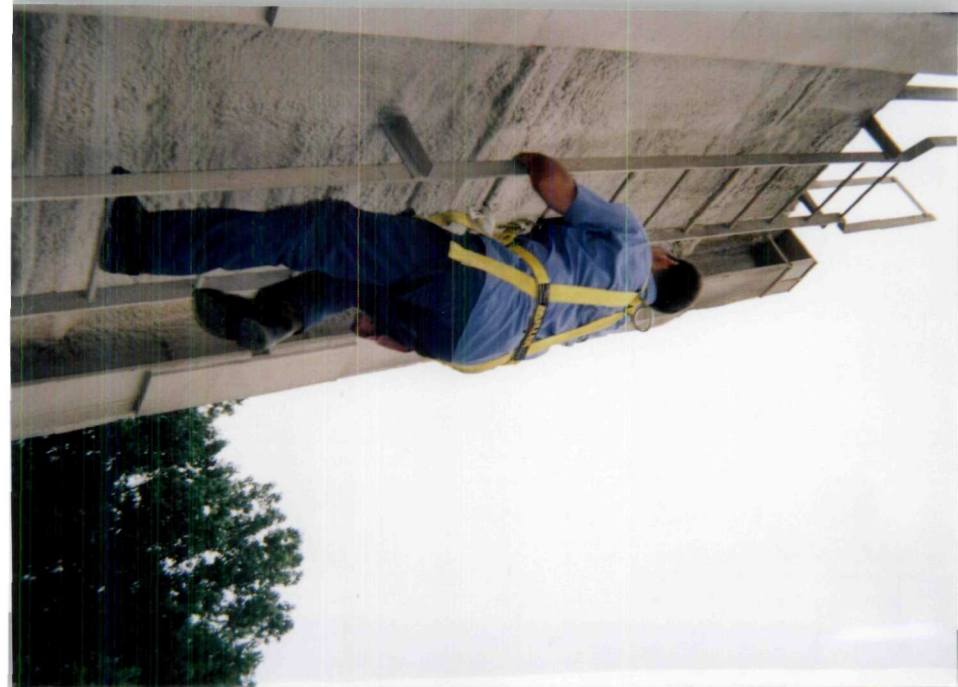
Description: Photo looking up at Tim Kirkland climbing the ladder to the top of tank T-102 to install the new demister.

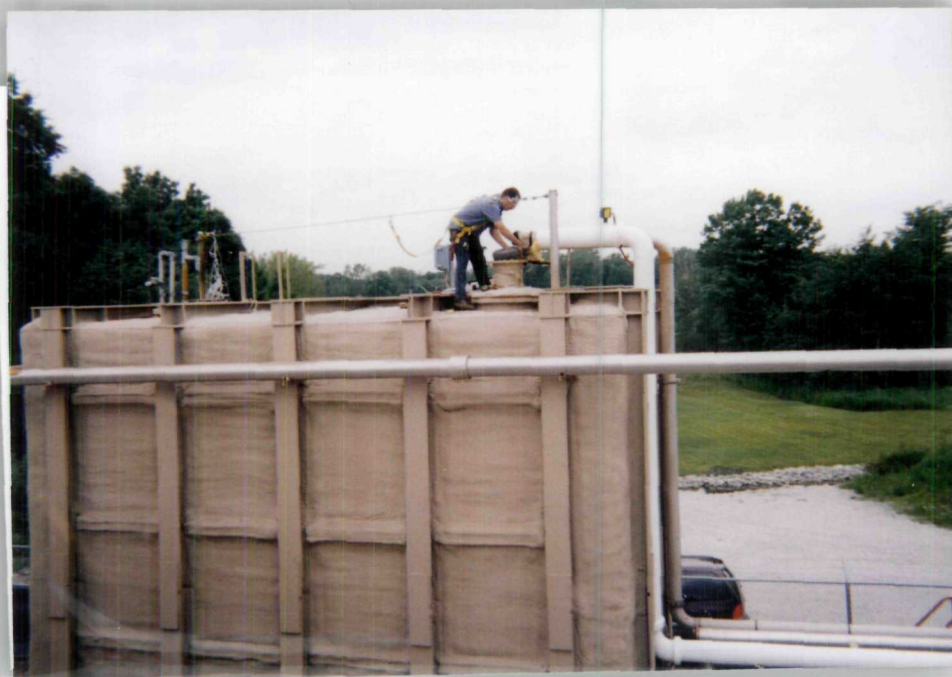
Description: Photo facing west showing Tim Kirkland installing the demister in the top of tank T-102. Note the fall protection harness tied off to the support cable.

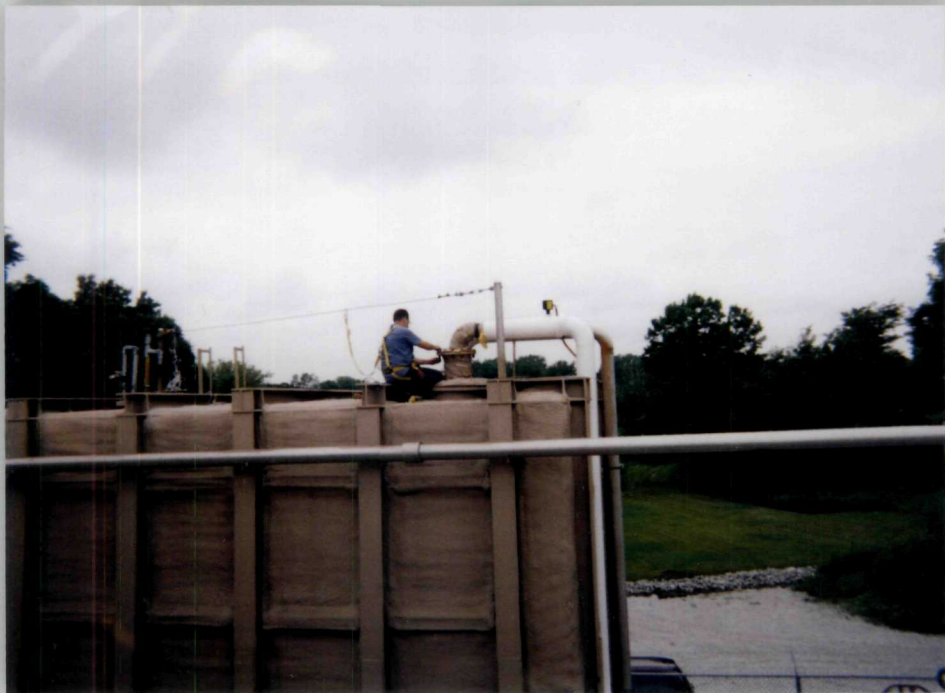
Description: Photo facing west showing Tim Kirkland reconnecting the vapor piping at the top of tank T-102 after installing the demister.

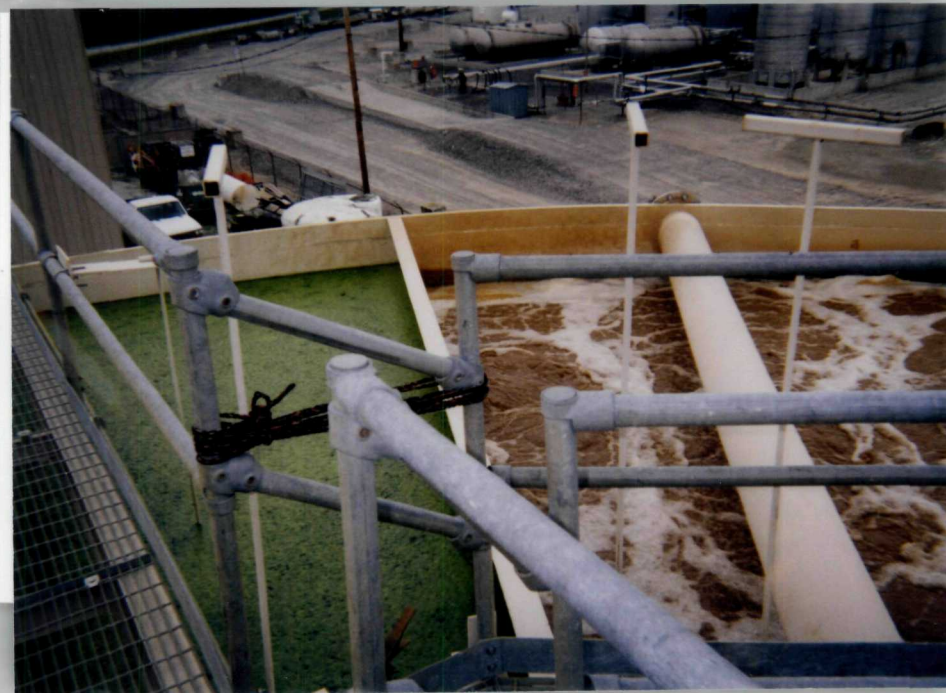
Description: Photo facing northeast from the top of ME-101 showing the algae growth in the left holding cell.

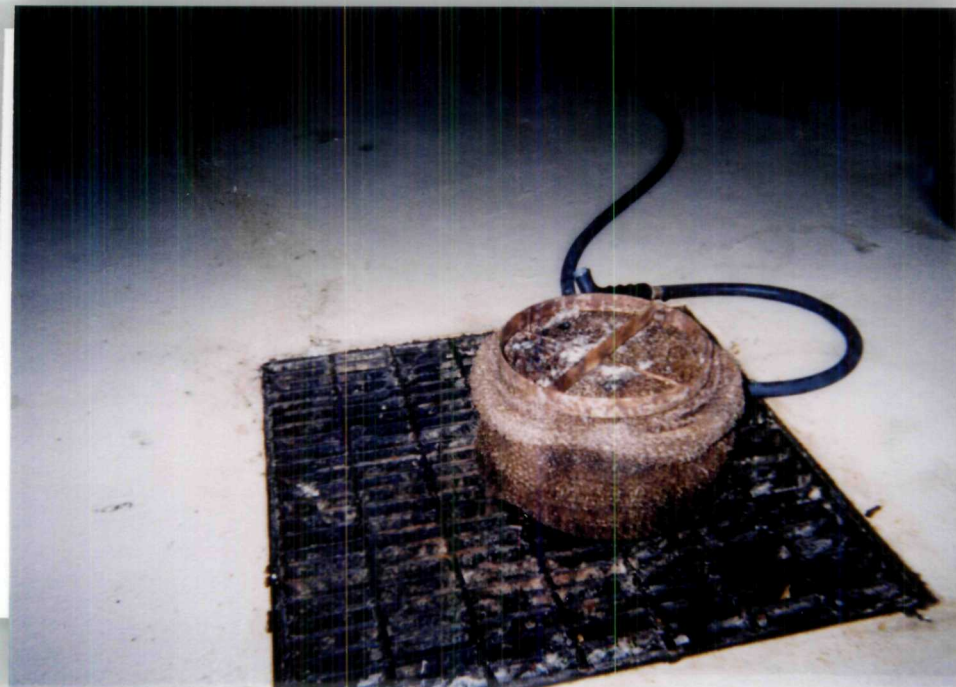
Description: Photo facing south showing the old demister screen after removal from tank T-102.

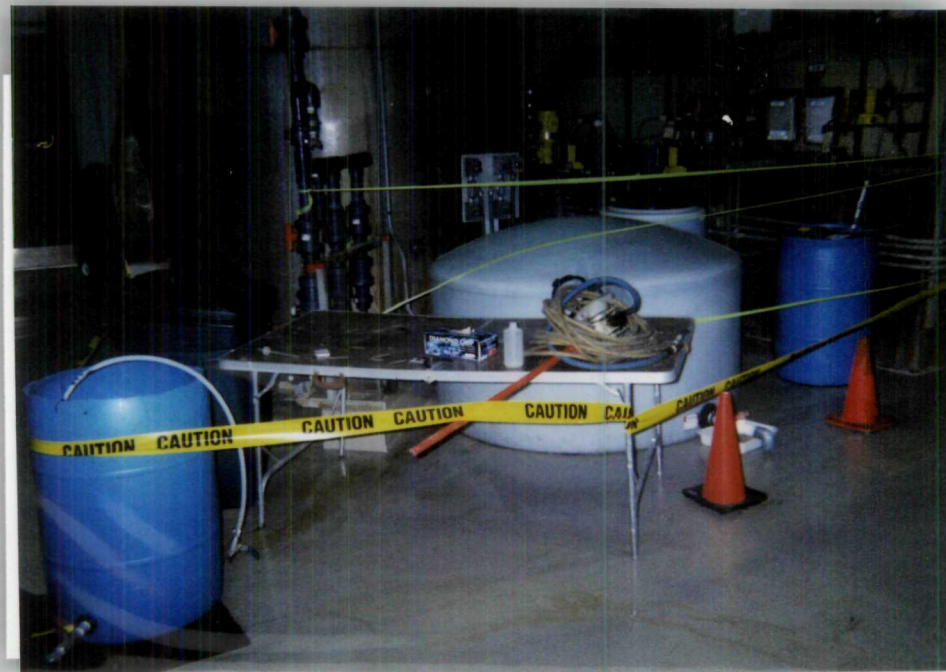
Description: Photo facing southwest showing the light gray poly tank into which the leaked sulfuric acid had been pumped. Blue drum on left contains acid after adding NaOH.

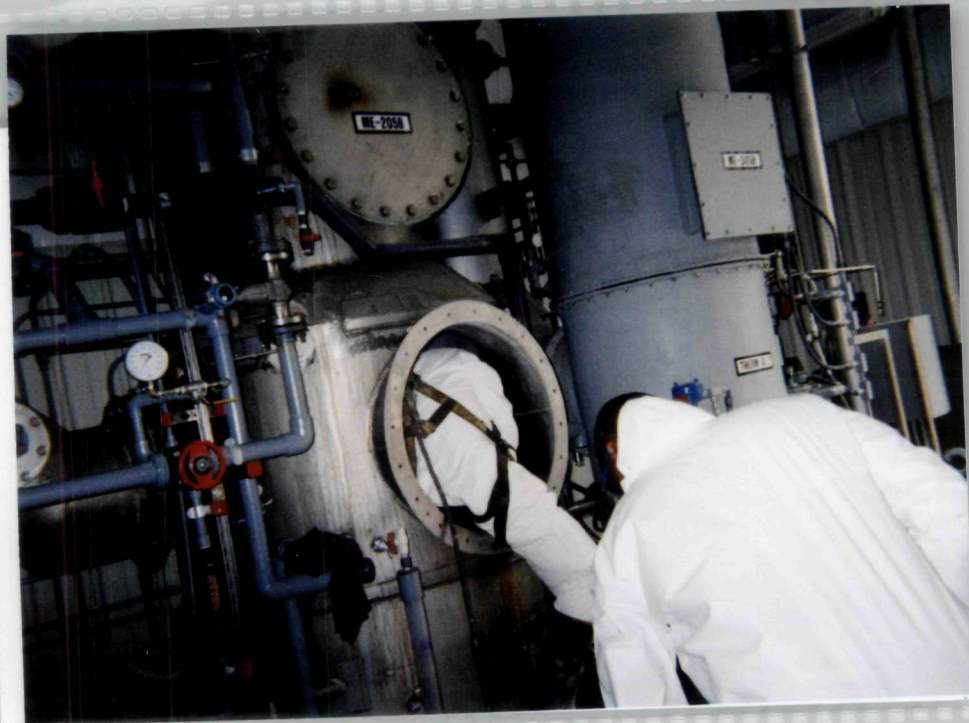
Description: Photo facing southwest showing CTL entering the Durr thermal oxidizer unit 1 scrubber. Note safety harness.

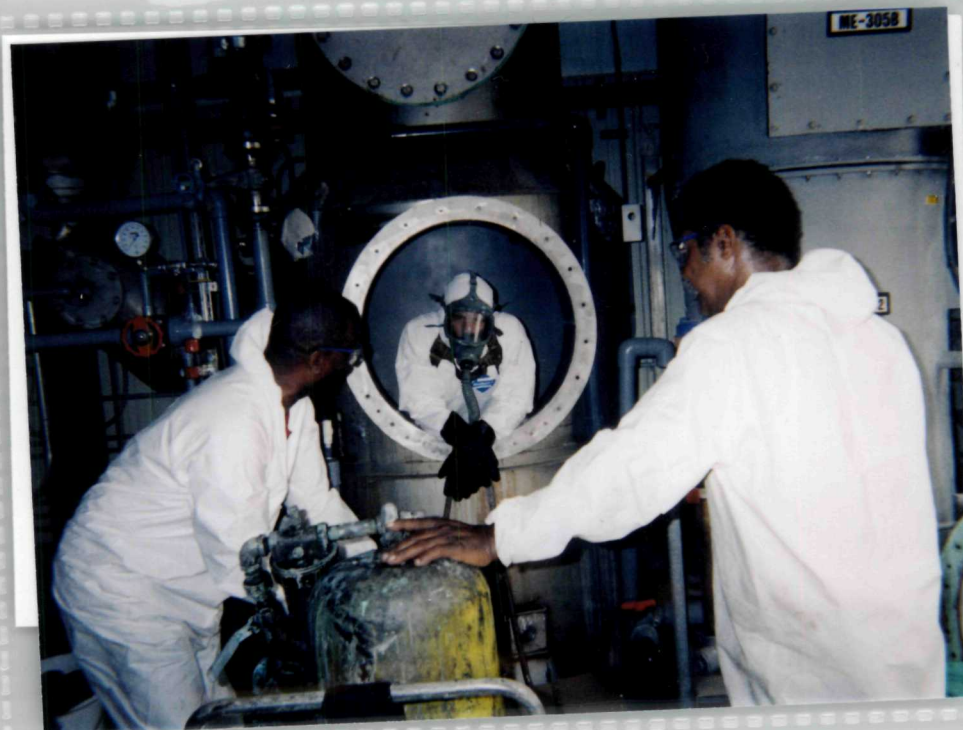
Description: Photo facing south showing CTL in the Durr thermal oxidizer unit 1 scrubber with safety harness and supplied air respirator.

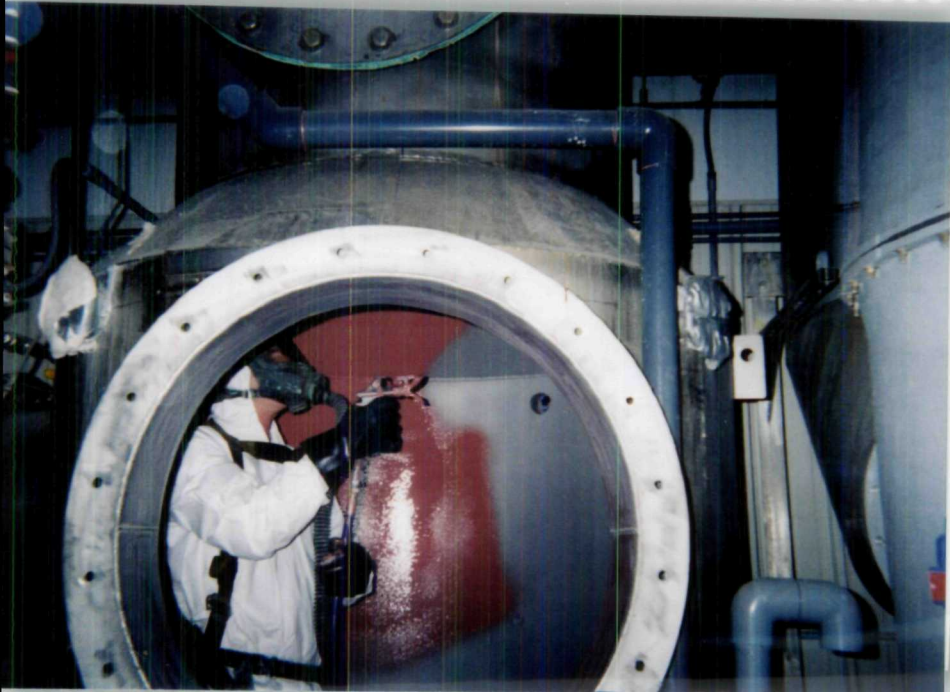
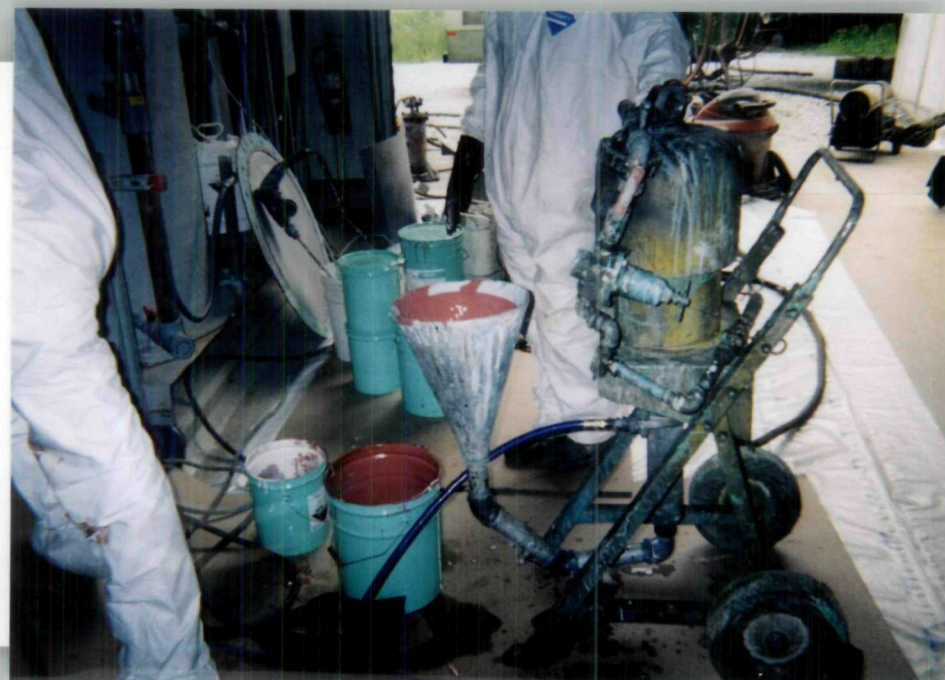
Description: Photo facing west showing the air operated epoxy pump.

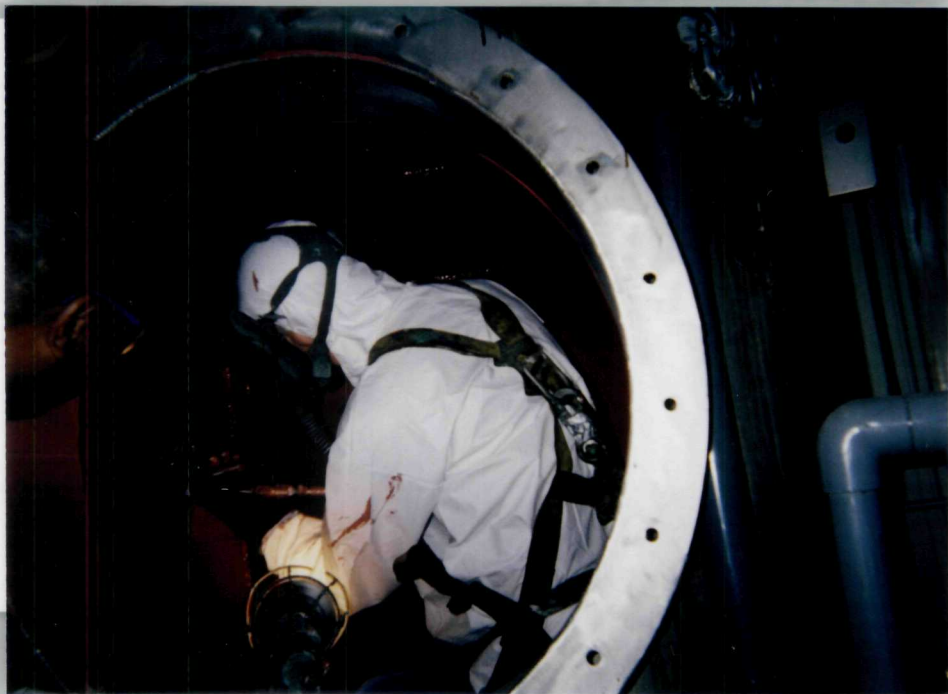
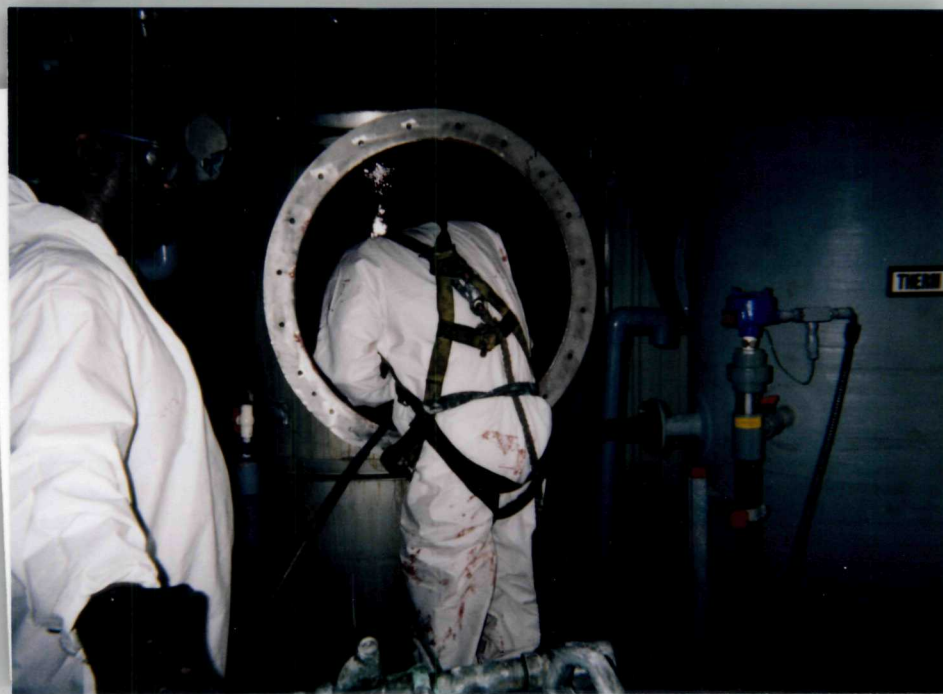
Description: Photo facing south showing CTL spraying epoxy onto the floor of the Durr thermal oxidizer unit 1 scrubber from the exterior.

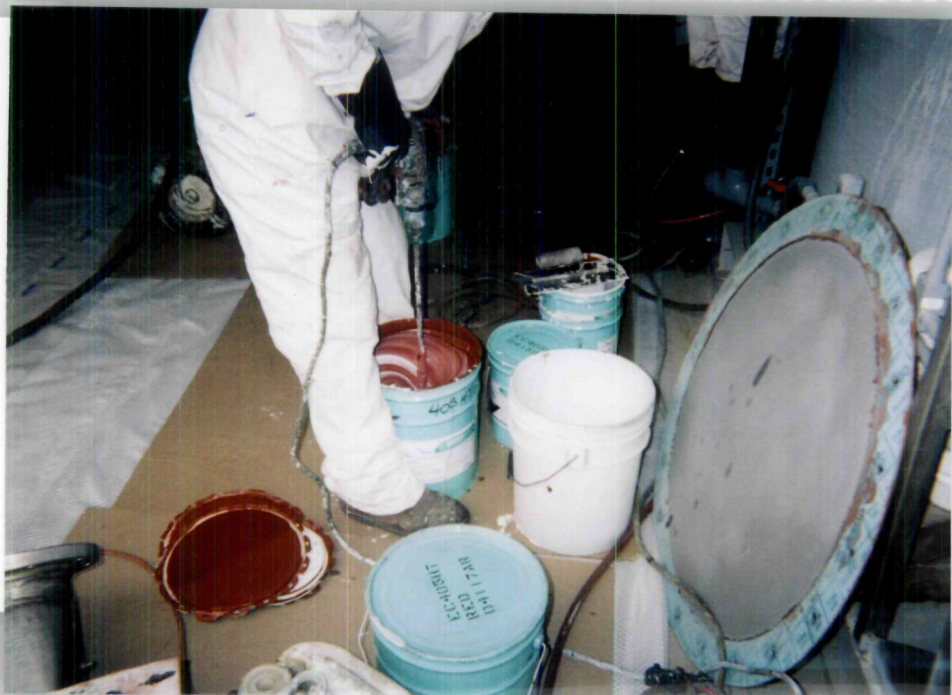
Site: American Chemical Service, Inc.  
 Proj. #: 46526  
 Roll: 59 Photo #23  
 Date: 06-16-04 Time: 13:33  
 Photographer: Larry Campbell  
 Description: Photo facing east showing the mixing of the catalyst and hardener for a new batch of epoxy.

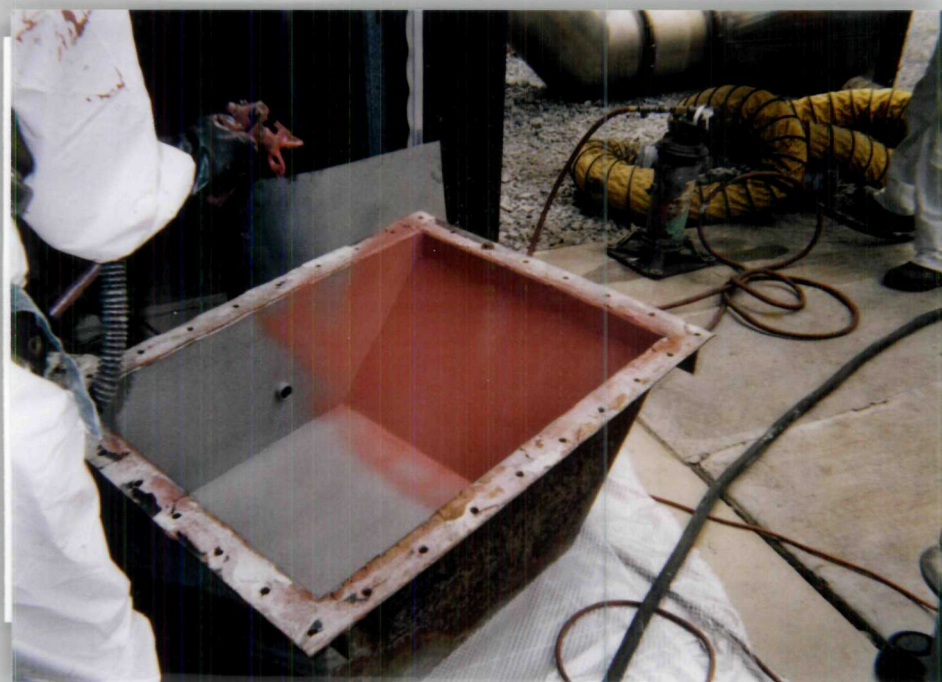
Site: American Chemical Service, Inc.  
 Proj. #: 46526  
 Roll: 59 Photo #24  
 Date: 06-16-04 Time: 13:35  
 Photographer: Larry Campbell  
 Description: Photo facing southwest showing spraying of epoxy on the front end of the Durr thermal oxidizer unit 1 scrubber.

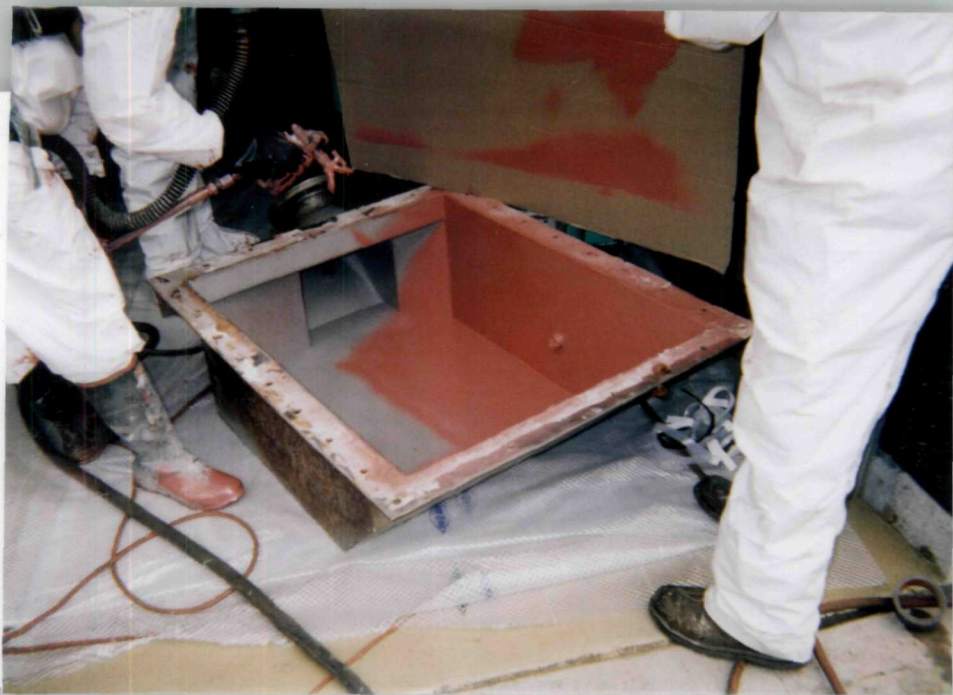
Site: American Chemical Service, Inc.  
 Proj. #: 46526  
 Roll: 59 Photo #25  
 Date: 06-16-04 Time: 13:36  
 Photographer: Larry Campbell  
 Description: Photo facing southeast showing spraying of epoxy on the front end of the Durr thermal oxidizer unit 1 scrubber.

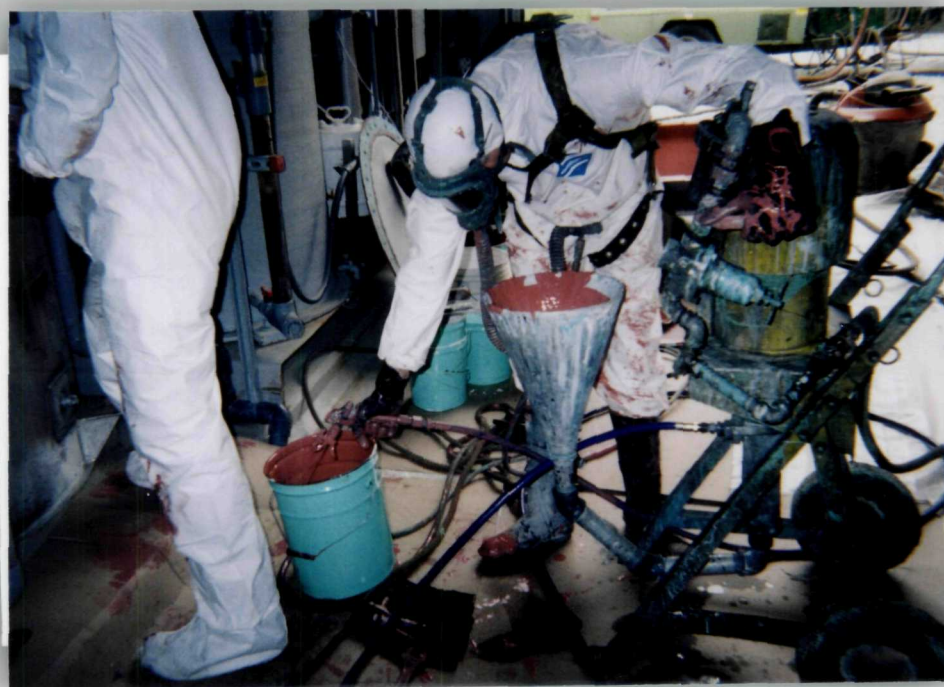
Site: American Chemical Service, Inc.  
 Proj. #: 46526  
 Roll: 59 Photo #26  
 Date: 06-16-04 Time: 13:39  
 Photographer: Larry Campbell  
 Description: Photo facing west showing CTL spraying solvent through the pump and lines to clean out the epoxy.

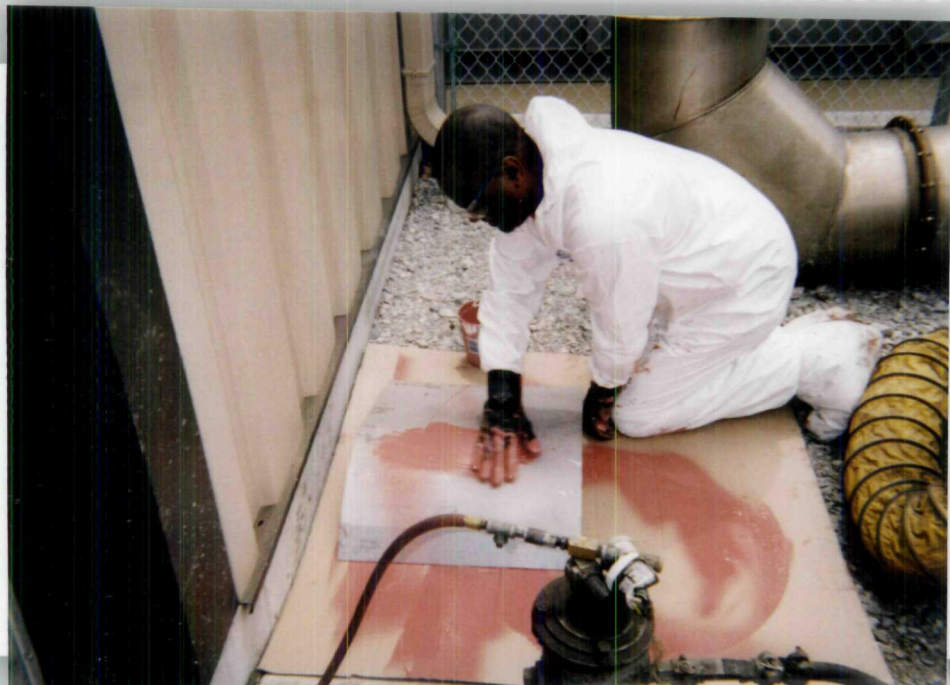
Description: Photo facing south showing hand application of epoxy to the baffle plate located in the Durr thermal oxidizer unit 1 scrubber.

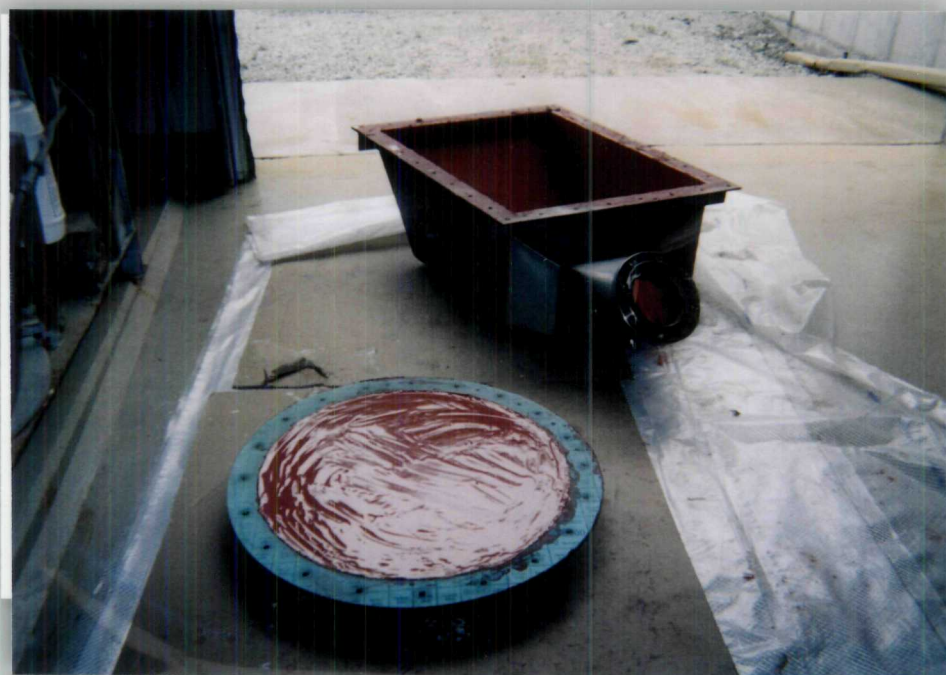
Description: Photo facing west showing the Durr thermal oxidizer unit 1 scrubber manway hatch cover coated with epoxy coating. Front end of scrubber in background.

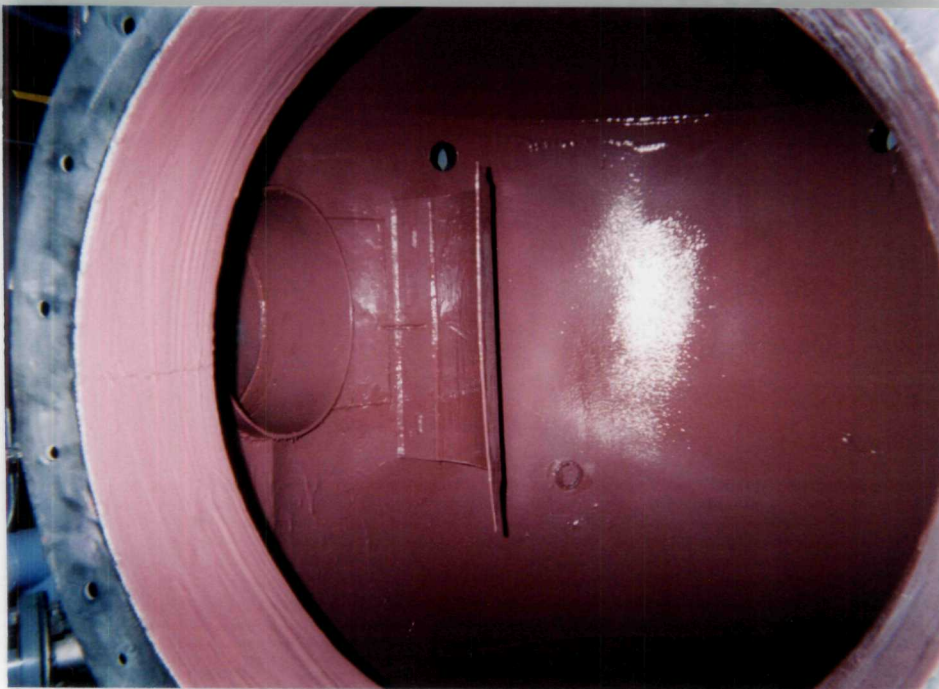
Description: Photo facing south through the manway into the Durr thermal oxidizer unit 1 scrubber showing the recently epoxy coated and installed baffle plate.

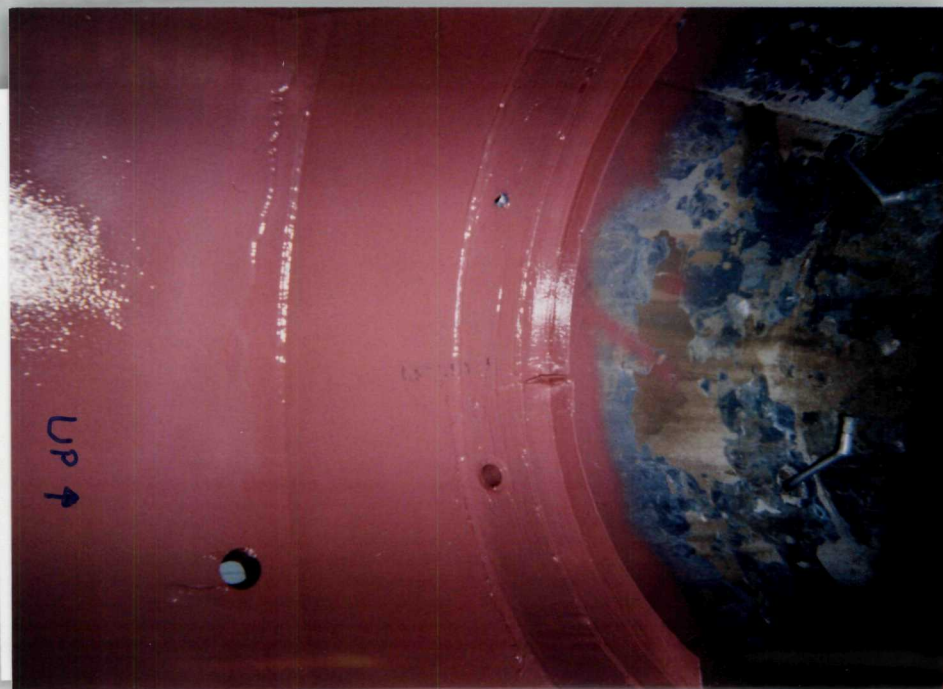
Description: Photo looking up into the interior of the Durr thermal oxidizer unit 1 scrubber showing the epoxy coated surface on the lower 7 ft and the uncoated portion above.

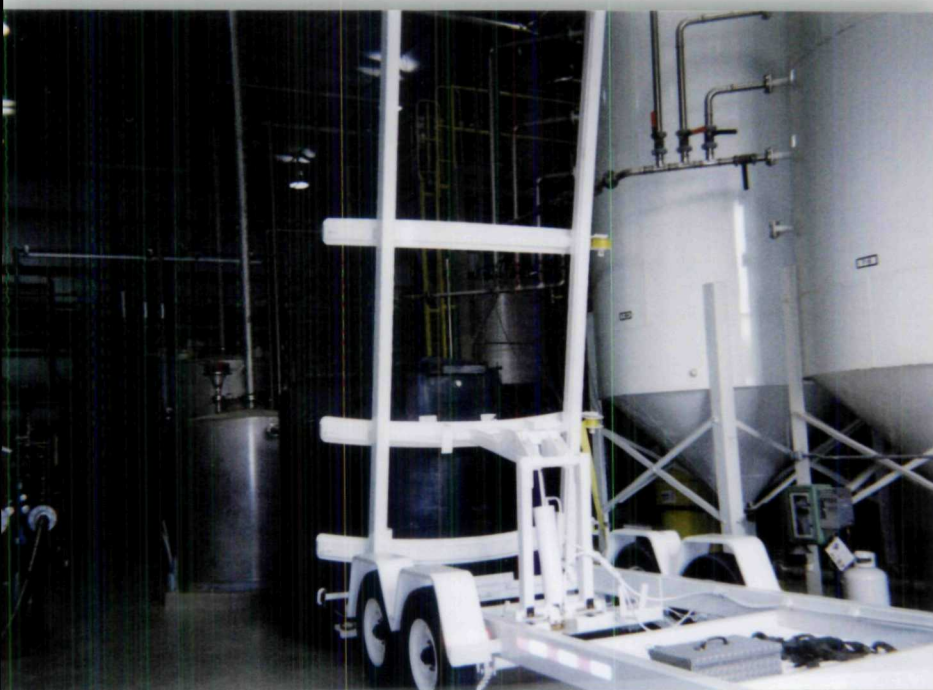
Description: Photo facing south at the rented 2,450 gallon tank for temporary storage of sulfuric acid (being unloaded from transport trailer)..

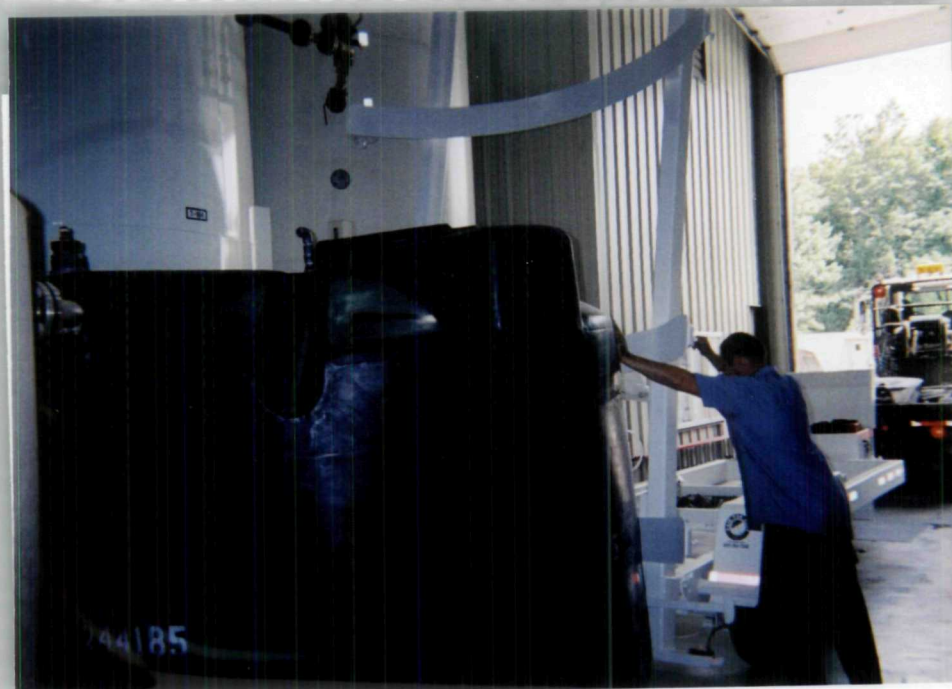
Description: Photo facing northwest showing the rented poly tank for temporary storage of sulfuric acid.

During the week of June 14, 2004, MWH rented several poly tanks to temporarily store the sulfuric acid. BVSPC expressed concern that the rental tanks did not have secondary containment. MWH subsequently installed secondary containment for the tanks during the week of June 21, 2004. MWH reported that it transferred approximately 4,000 gallons of diluted sulfuric acid from the leaking tank and its secondary containment into the temporary poly tanks. MWH also reported that it identified two leaks in the storage tank, one at the inlet valve and the second at the outlet valve, both located near the base of the tank. MWH is currently evaluating whether it will replace or repair the leak. MWH also reported that it is evaluating locations where it can either dispose of or recycle the diluted sulfuric acid.

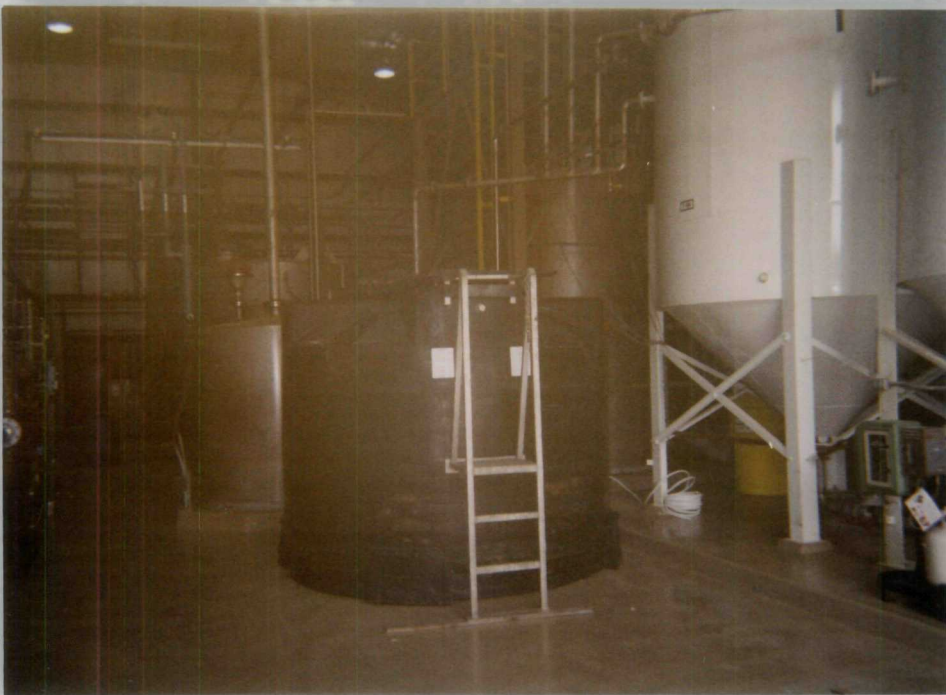
Description: Photo facing south showing the rented poly tank for temporary storage of sulfuric acid with an access ladder.
